Sub Grade Improvement Using Stone Column for Semi High Speed And Heavy Axle Load – A Case Study on Actual Implementation on Doubling Work of Kharagpur Division

Amit Kumar Roy*

Synopsis:

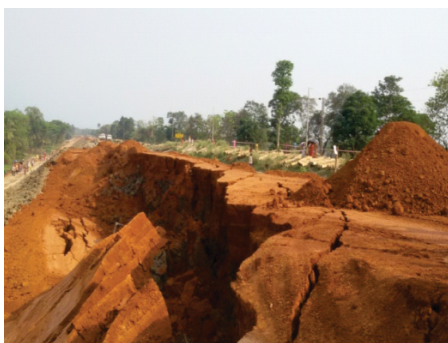
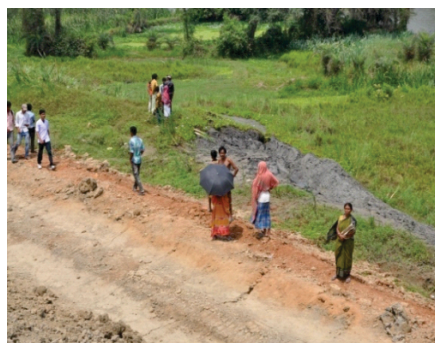
and linking of track was in progress, suddenly the sub soil of the portion of bank has subsided and crumbled between section Keshabpur and Mahishadal about 500 m length at the approach of Major Bridge No. 69 where the bank height was more than 9 m.

- 1.4 The sub-soil was taking load of newly constructed bank upto 7 m height but the sub soil of that area was not able to take the vertical load from 7 to 9 m as the height bank height was 9 m at Bridge Approach to give vertical clearance on this bridge for navigation purpose. Just after the bridge there was Halt Station on Island platform which added further constraint and load on newly constructed bank.

A few pictures taken after the incident are placed below.

One of the reason of subsidence was primarily caused due to fast pace of construction due to less working period availability and chasing from user department for speedy completion of the work which did not allow the pore water pressure of the underlying soft clay layer of approximate thickness of around 10.0 m below ground to dissipate. As a result, the underlying layer having inadequate bearing capacity was unable to withstand the loading and failed in a typical base failure.

There are methods like pre loading, vertical drain, stone column prescribed in IS Code for sub grade ground improvement. As pre-loading is a long time taken method and a vertical drain being found unsuitable for such situations, the stone column deep into the underlying layer as the most suitable method according to modern Engineering practice as per IS Code guideline for a faster consolidation of sub-soil to complete the project.

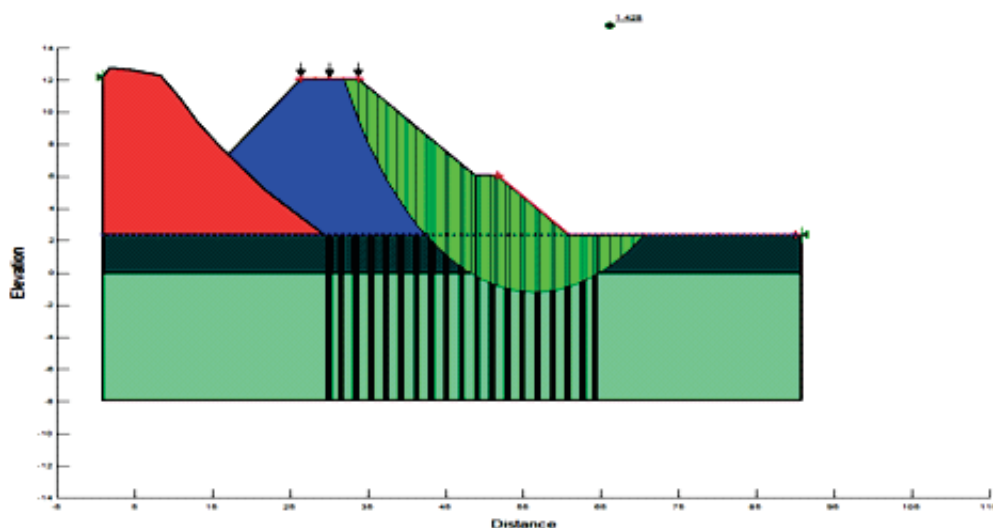
Before commencement of Ground Improvement work, RDSO was involved to give final recommendation. The stone column and slope stability analysis was done based on the site condition and the stability analysis was done based on Bishop /method on computer iteration process to achieve factor of safety of atleast 1.4 for effective stress on soil. The typical stability graph which is shown below

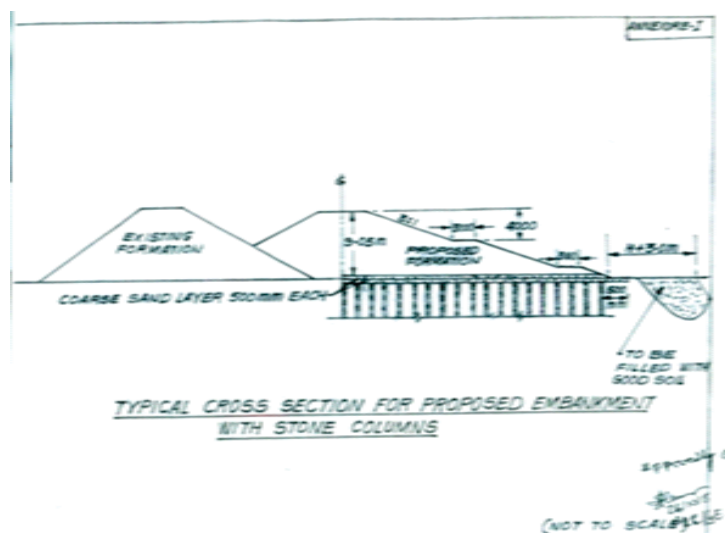
- Design consultant should be involved in execution and quality control.
- Coarse sand layer of 50 cm thickness below GL (at the top of stone column) should be provided and it should be extended 50 cm beyond toe, as shown in Annexure-I.
- As reported by the RDSO officials after inspection of the site, a pond is existing very near to the toe of failed embankment. Normally the distance of pit/pond should be situated $(H+3)$ m away from toe of embankment where H is the Height of the embankment to avoid base failure. Before commencing the work, the pond should be filled with good type of soil upto $(H+3)$ m, distance beyond toe with proper compaction, as shown below

4. Coarse sand layer of 500mm thickness has been provided above stone column and extended upto 50 mm beyond toe as per sketch provided by RDSO.
5. The existing pond near toe of embankment has been filled up with good quality soil upto (H+3)m away from the toe of embankment (H = height of bank) and properly compacted.

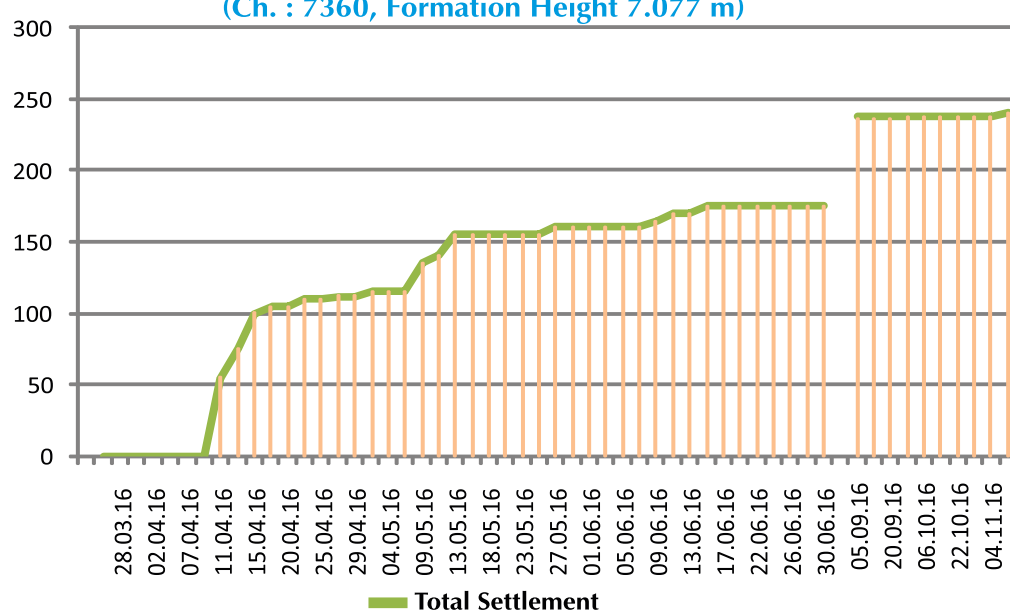
Total Maximum Settlement of S-6
(Ch. : 7360, Formation Height 7.077 m)

While going through the settlement marker records, it is noted that the settlement is more or less stabled One typical plotting is given below. For S-6 where the total settlement was maximum and found very close to the total settlement of predicted value.

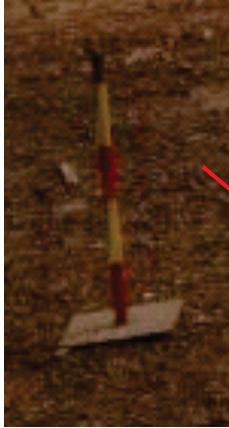
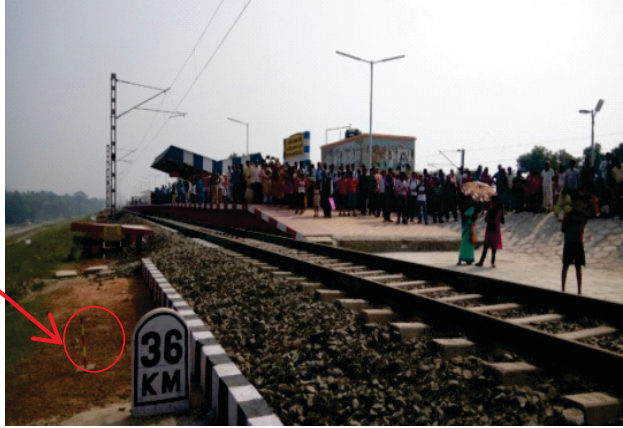
Settlement Marker Fixed from settlement Point

After completion of formation before laying of track the settlement points were transferred to settlement marker again demarcated from S1 to S8 and settlement measurements were taken continuously are recorded.

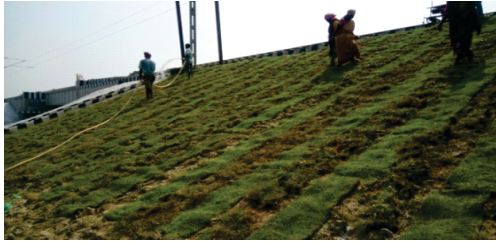
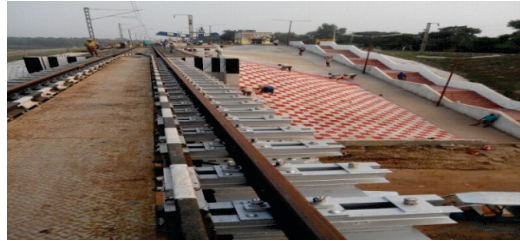
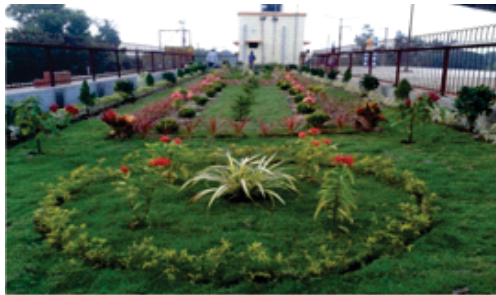
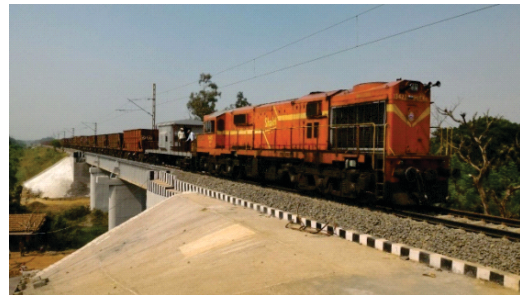
9. The section was inspected by CRS on 25.11.2016 for commissioning and speed trial at 115 kmph with satisfactory performance was completed. Few photographs are shown below.
