Rolling Contact Fatigue Behavior of Rail under High Axle Load Conditions

Sujeet K. Jha, IRSE*

Synopsis

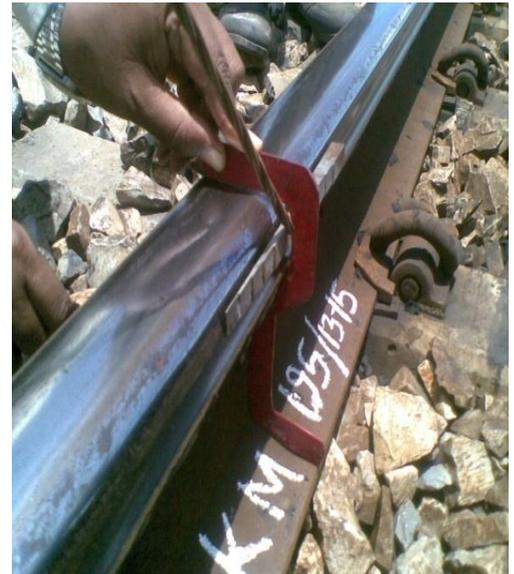
3.3 Excessive wear in gauge face

- Excessive wear has been noticed especially the track having $>1D$ curve. It mostly appears in the outer rail of the curve by traction, creepage and flange force.
- It also appears in lower rail of curve due to lateral friction and spin creepage by wheel.
- It also occurs in straight track having gauge difference of defective subgrade.
- Due to defect in wheel and its defective movement unintentionally creates wear at any location of rail.
- It is important once the wear start in all wheels mostly follow same path further aggravates the wear.
- By reducing the section of rail head increases the stress and finally results to rail failure.
- Solution: Remaking the rail profile and greasing of the gauge face.
- Rail profile grinding generates artificial wear and developed micro cracks is removed.
- China Railway has started a project for mechanical greasing to enhance the life of rail.

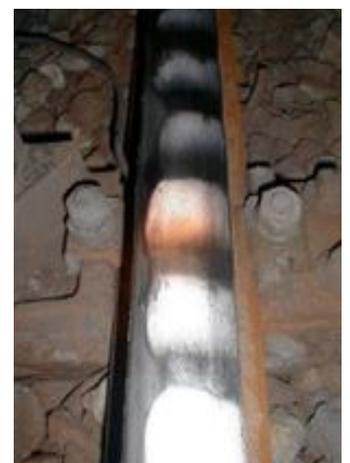
3.5 Rail Surface corrugation

- Rail Surface corrugation is a frequently occurring rail wear pattern that arises mostly in curves, although that it's also possible on tangent track.
- Rail Surface corrugation is considered with wavelengths between 20 mm and 200 mm.
- The wear pattern results in reduced rail and wheel lifetime and it can lead to urgent safety measures (rail replacement).
- At the wayside, wheel/rail noise creates discomfort to the passengers and nearby community.
- The passage of a bogie in small curve leads to important dynamic forces between wheel and rail in all directions: tangent, axial and vertical.

- These forces are due to important friction between wheel and rail due to curving (tangential and radial friction forces) due to flange friction on high wheel and poor subgrade or ballast underneath, loose/ineffective fittings,
- Rail and wheel imperfection due to misalignment in wheelset, difference in diameter between wheels of same set, band axle misalignment & kink in rail/weld.
