# Surviving RCF: Emerging Frontiers

Parmeshwar Funkwal\*

*Rolling Contact Fatigue (RCF) defects are hallmark of most of the railroads carrying heavy axle loads and intensive passenger traffic. RCF defects of nearly vertical orientation are one of the most lethal types of rail defects on account of their low chances of detection in rail testing regimes prevailing on rail networks. Detection of defects with favorable orientation under adverse rail surface condition is also a challenging task. The paper highlights Indian Railways' experience in dealing with these defects and R&D efforts made to develop potential technology for their detection.*

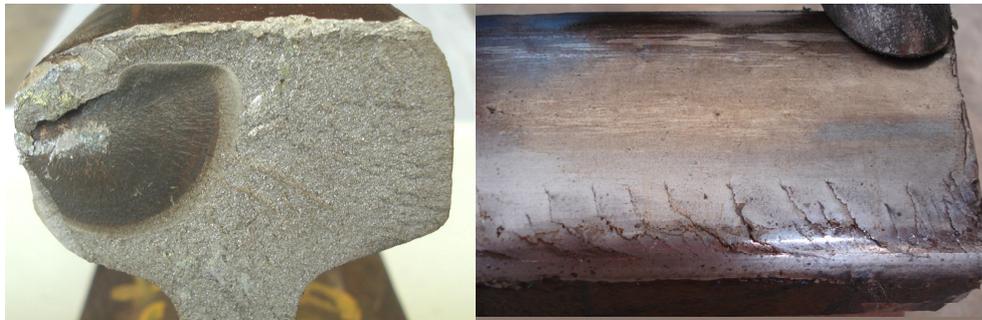
**Plate1, 2:** Transverse Defect in UIC 60, 880 Grade Rail covering 30% of railhead area leading to derailment at New Faridabad Station in April 09. Nucleus of fracture initiation corresponds to landing of shear crack present on gauge side of rail table. Adjoining Plate shows extent of Head Checks at the location. Question: Did head checks mask defect?

2.4.1 Rail profile grinding is not being practiced on IR. Thus most of the 880 grade rail on IR network is commonly exhibiting cyclic head checks. In certain circumstances the head checks can seriously impair the capability of detection of defects sitting beneath them even though they might be progressing at favorable orientation.

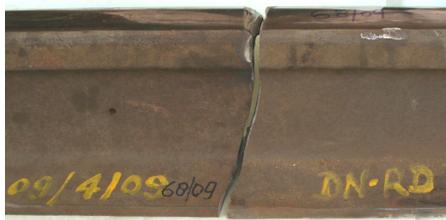
**Plate 3:** Rail pieces in juxtaposition exhibiting angle of inclination (Approximately 6 degree from vertical) of Transverse Defect. Ultrasonic test report of the rail less than 15 days prior to failure did not indicate any defect. Question: Did orientation play a role in non detection?

2.5.1 RCF defects of orientation flatter than 20 degree from vertical are also being encountered increasingly. These types of defects can also pose serious problems in their detection. Earlier, it was generally believed that RCF defects of nearly vertical orientation are a typical feature of rails carrying bi directional traffic. However, recent cases suggest that this hypothesis is not entirely correct. One of the recent cases of this type is the one which led to derailment at New Faridabad (Please see Plates 1,2 &3below). Although it is customary to believe that all defects have facets which reflect certain ultrasonic energy, in a real life testing situation detection of feeble signal is easier said than done.

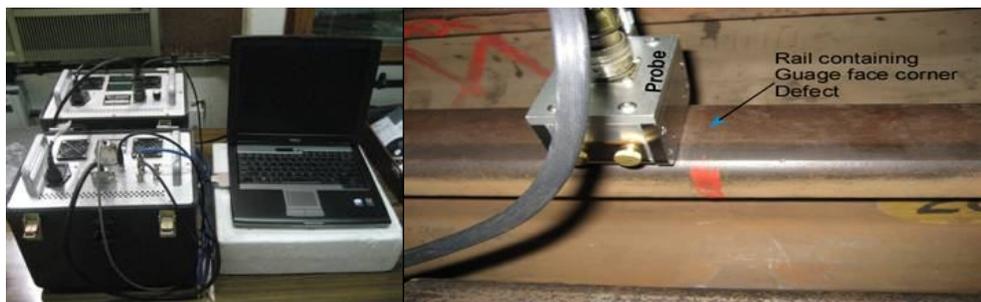
5.2 Initially generic EMAT equipment along with normal and angle probes was procured from Innerspec Technologies Inc, USA in order to obtain first hand experience with EMATs.

**Plate 6: Power Box Set up from Innerspec and Testing of Rail Containing Natural GFC defect**
