# Maintenance of Points and Crossings under Mixed Traffic Scenario of Semi High Speed and Heavy Axle Load - Challenges, Problems and their Innovative Solutions

## Synopsis

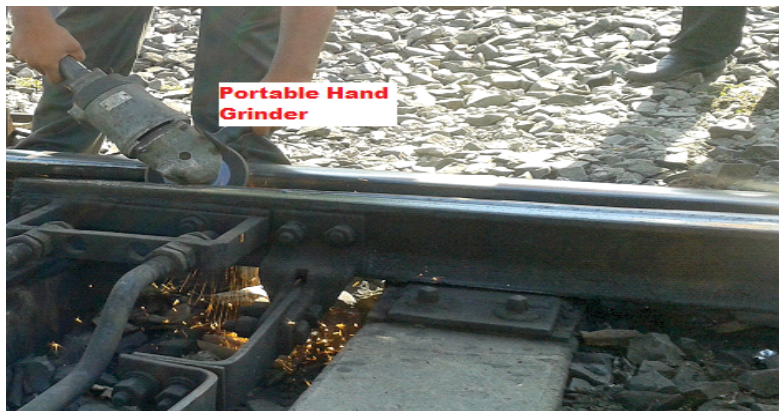
Use of portable hand grinders for removing of the burr as and when required, is the best solution to this problem. It is very much practical, safe and easy as far as its operation is concerned.

Burr is formed due to plastic deformation and flow of metal from gauge face corner, which if not attended within time, leads to non setting of points and breakage/chipping of tongue rail. Existing method of burrs removal in vogue is by using chisel and sledge hammer. This prevalent practice is clear-cut violation of handling instructions for 90UTS rails, and this may leads to development of stresses and consequent fracture of stock rail in long run.

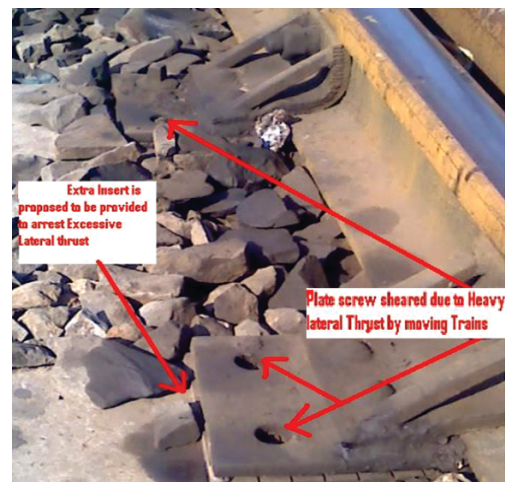
Plate screws are used to hold the slide chair but due to lateral thrust exerted by rolling stock, the plate screws get sheared off which results in the widening of the gauge and disturbance of alignment. Further it is also very difficult to remove the broken part of the plate screw and replace by the new one every now and then.

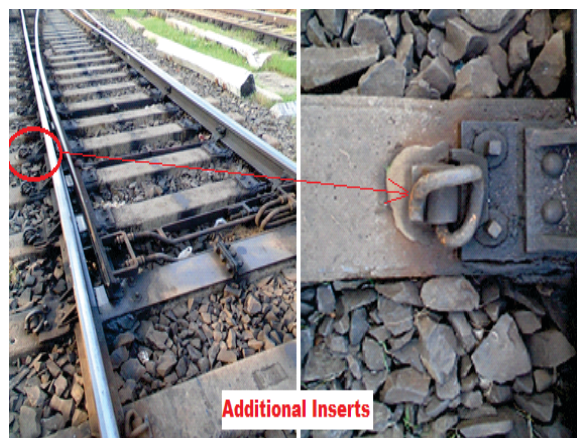
To bear the lateral thrust of rolling stock wheels flange, Inserts are provided on the outer side of the slide chair up to the heel block. This practice prevents the shearing of plate screws.

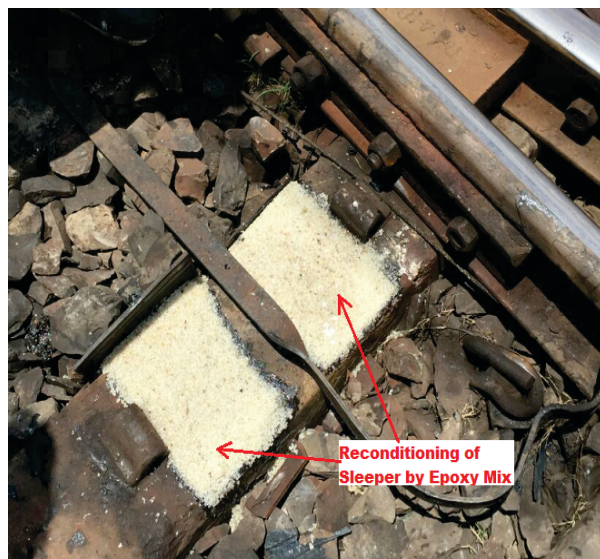
This problem can be solved if the dent/groove developed in the sleepers is filled up by the mortar of epoxy and coarse sand mix. This mixture is a very good and reliable material to be used for filing the groves and dents of the sleepers. It is also highly durable and withstands the dynamic train loads.

The sleepers below the crossing body i.e. sleeper no. 66 to 73 in case of 1 in 12 turnout and 43 to 48 in case of 1 in 8.5 gets dented

due to hammering impact of rolling stock while negotiating the crossing portion of turnout. This results in the further deterioration of crossing assembly due to loosening of rubber pad and the cross levels also changes and form twist under load thus resulting in bad riding. The fan shape sleepers are available in sets only, so if the dented crossing sleepers are changed by the new ones than the whole set has to be procured and the rest sleepers will be wasted.

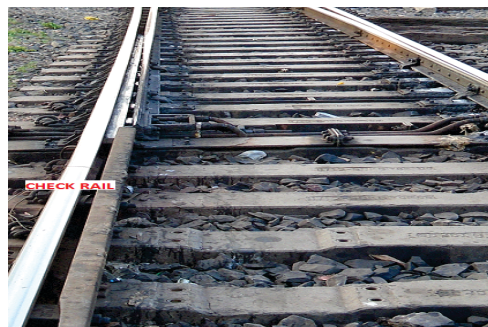
This problem can be minimised by regular application of grease on the gauge face of the tongue rail and providing a small check rail near the ATS of the switch of opposite side.

The problem of excessive lateral wear of switches is common on the turnouts which are laid on the inside of the curves. Due to the lateral wear the renewal of switch is required to be done before its service life or codal life is over and if not changed there is always a chance of fracture of tongue rail or stock rail and may cause serious mishap.

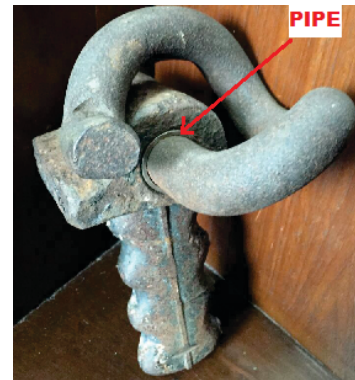
This problem can be satisfactorily solved by reconditioning of the inserts either by depositing the metal inside the insert hole/eye by the welding electrode or by inserting a metal pipe of suitable size inside the eye/hole of insert.

The hole/eye of the inserts of the sleeper gets elongated due to wear and tear which in turn reduces the toe load significantly and even the ERC get loose and fall after passing of one train after driving them.

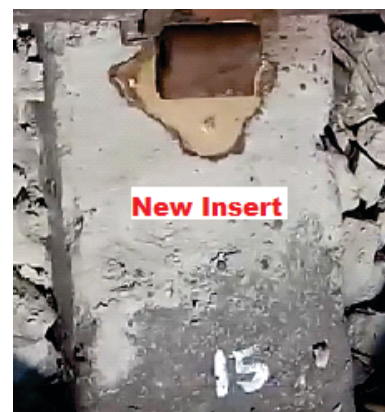
There is a solution for this type of problem. The worn out inserts can be removed and new inserts can be fixed using the epoxy mix if the otherwise condition of sleeper is good. This practice is very economical in comparison to the replacing those sleepers with new one.

Some time in highly corrosion prone areas the inserts in the points and crossings areas gets highly corroded and even breaks during the driving of ERCs. In these cases the PWIs use to change the sleepers and the remaining sleeper of the set is wasted.

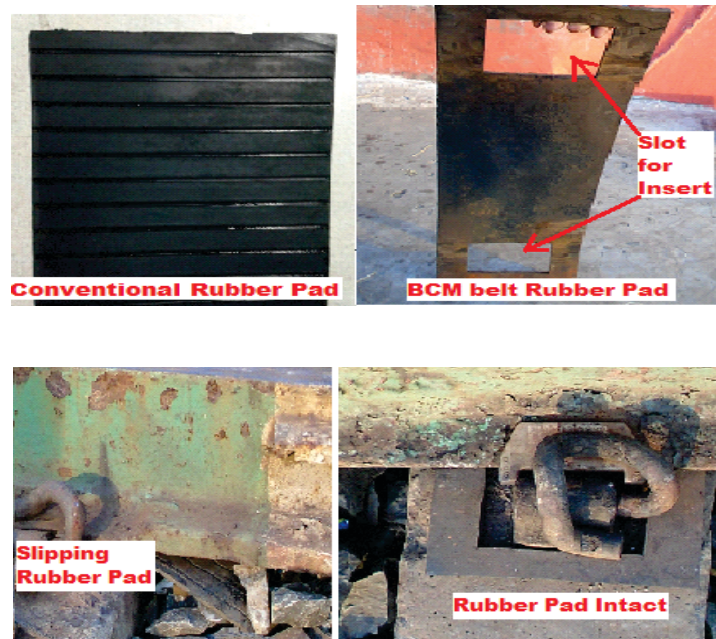
The conventional GRSP as shown in the photograph is not having any slot by which it can be kept attached to the insert and prevent its slipping. In our section we have used the BCM conveyor belt for this purpose by cutting it into suitable sizes as per requirement and making a slot in them for housing the MCI inserts so that it do not slip and come out. The thickness of BCM belt is also more so it protects the sleeper against impact more and also not easily crushed.

The GRSP provided underneath the crossing tends to slip and come out and get dropped which in turn exposes the sleeper directly to the impact of rolling stock and thus damage the sleeper.
