Rail Wheel interaction in the context of heavy axle load

R.S.Kannan

S E/P.way/USFD/MAS

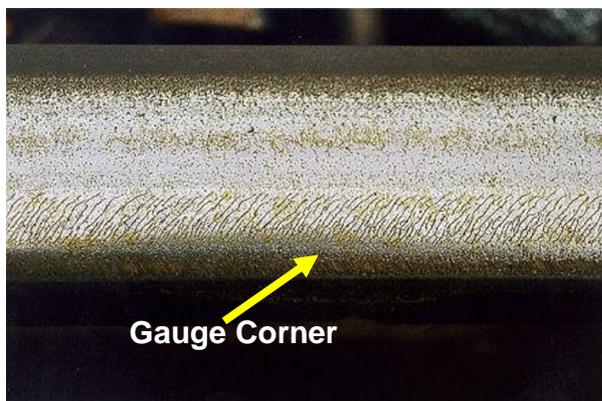
Initial stage

Gauge corner cracks/head checks are groups of fine surface cracks at the gauge corner at regular intervals along the rail (1–6 mm), mainly on outer rail of curves, can grow to 2-5 mm in depth, at a downward angle of about 10° to 30° to the rail surface, gradually spreading across the rail head. Generally contact stresses are low in the crown area and high contact stresses are generated on the gauge corner of the outer rail and they break out as spalls.

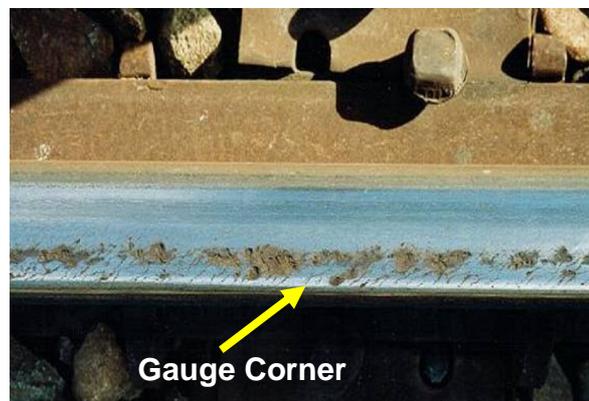
Severe stage

Gauge corner cracks/head checks may also be found near the welds as welded profiles may vary slightly in comparison with actual rail profiles. A slight variation in weld profile has a major effect on contact stresses. If head checks are not controlled, they can cause rail break. Grinding is the most common practice employed to remove gauge corner cracks/head checks and severe gauge corner cracks /head checks require immediate replacement.

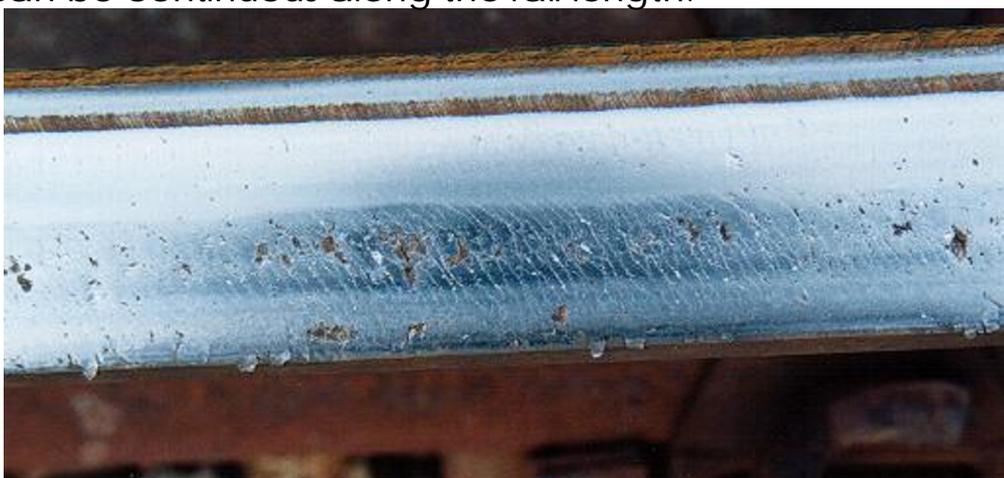
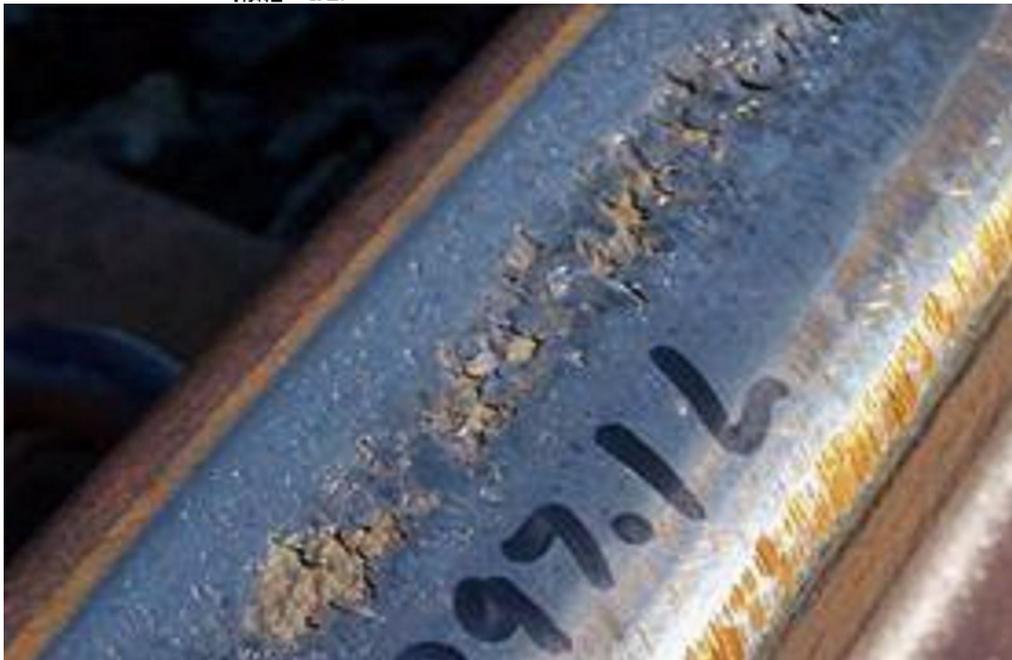
A surface condition that occurs on the running surface of the inner and/or outer rails. Initially the defects appear as a snakeskin like pattern on the rail head. In the latter stages the cracks produce "spalls" that can be up to about 10-15 mm wide, up to 3 mm deep, and can be continuous along the rail length.

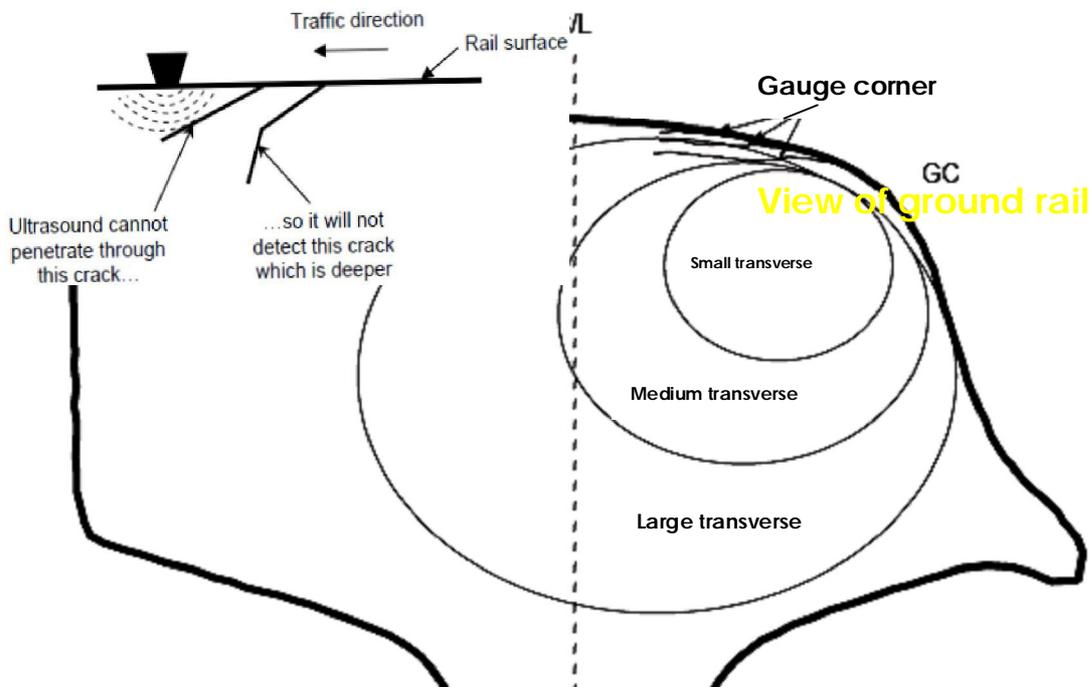
Gauge corner cracks/checking and various transverse defects

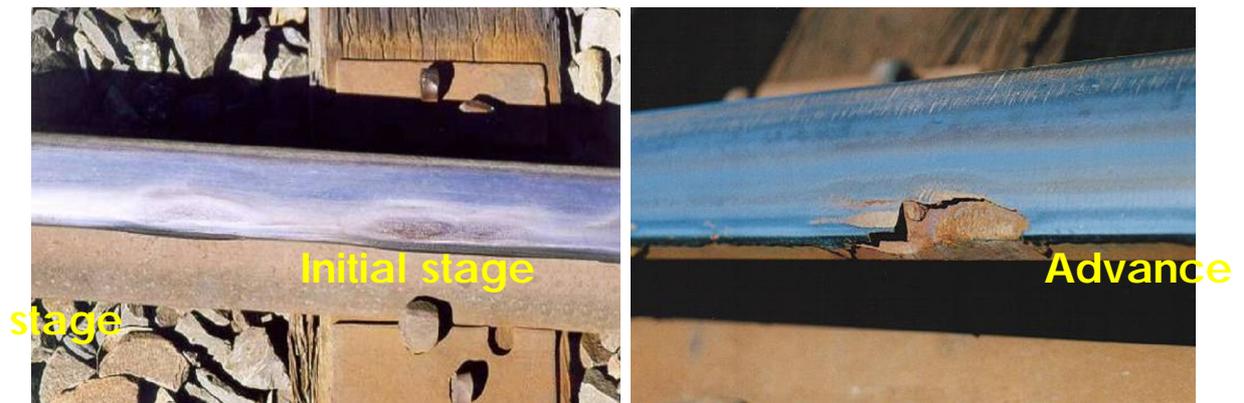
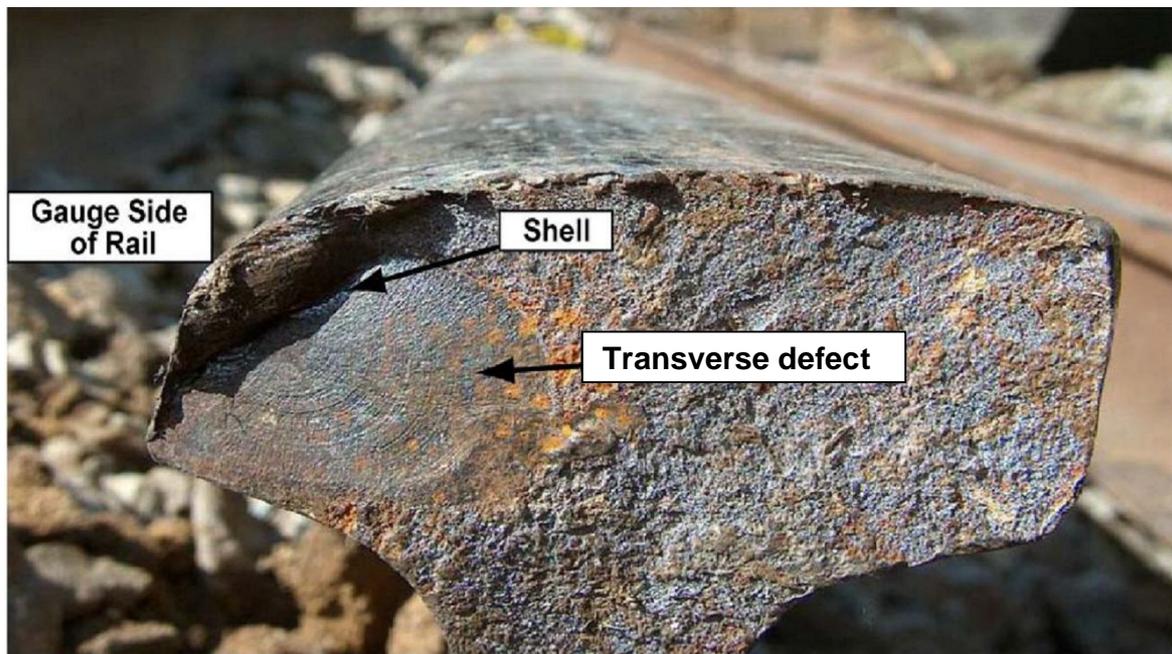
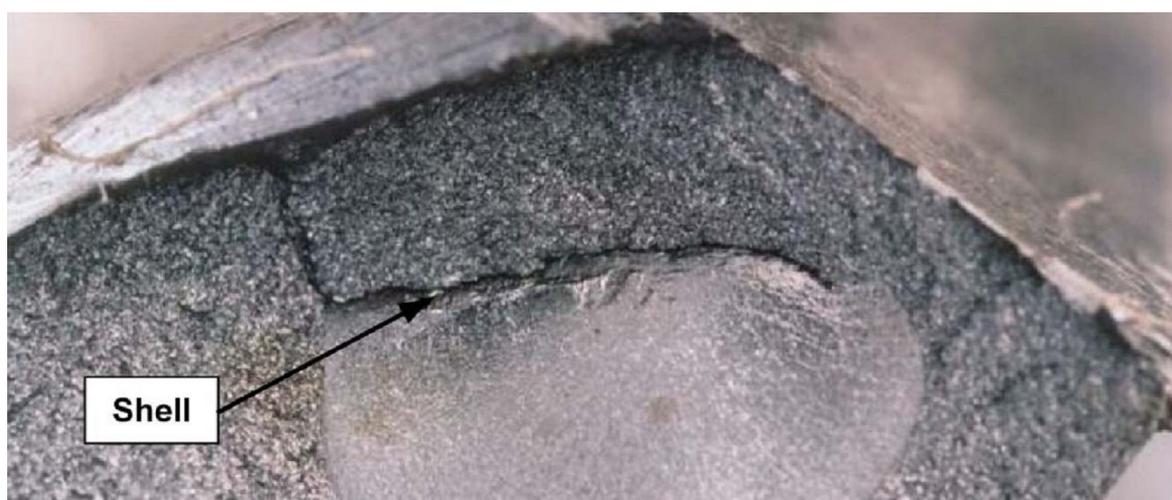
This is an internal defect that initiates at a depth of 2-8mm below the gauge corner of the outer rails of curved track on higher axle load routes. In the initial stages of development, shelling defects become

noticeable as dark spots in the gauge corner region of the rails. Shelling defects do not form as regularly along the rail as gauge corner checking defects. The cracks can continue to grow in a longitudinal direction on that plane for some distance at an angle of about 10°-30° to the rail surface, and then either spall out into a shell or turn down and form transverse defects which can continue to grow on a transverse plane and, if not detected in time, eventually lead to rail failure.

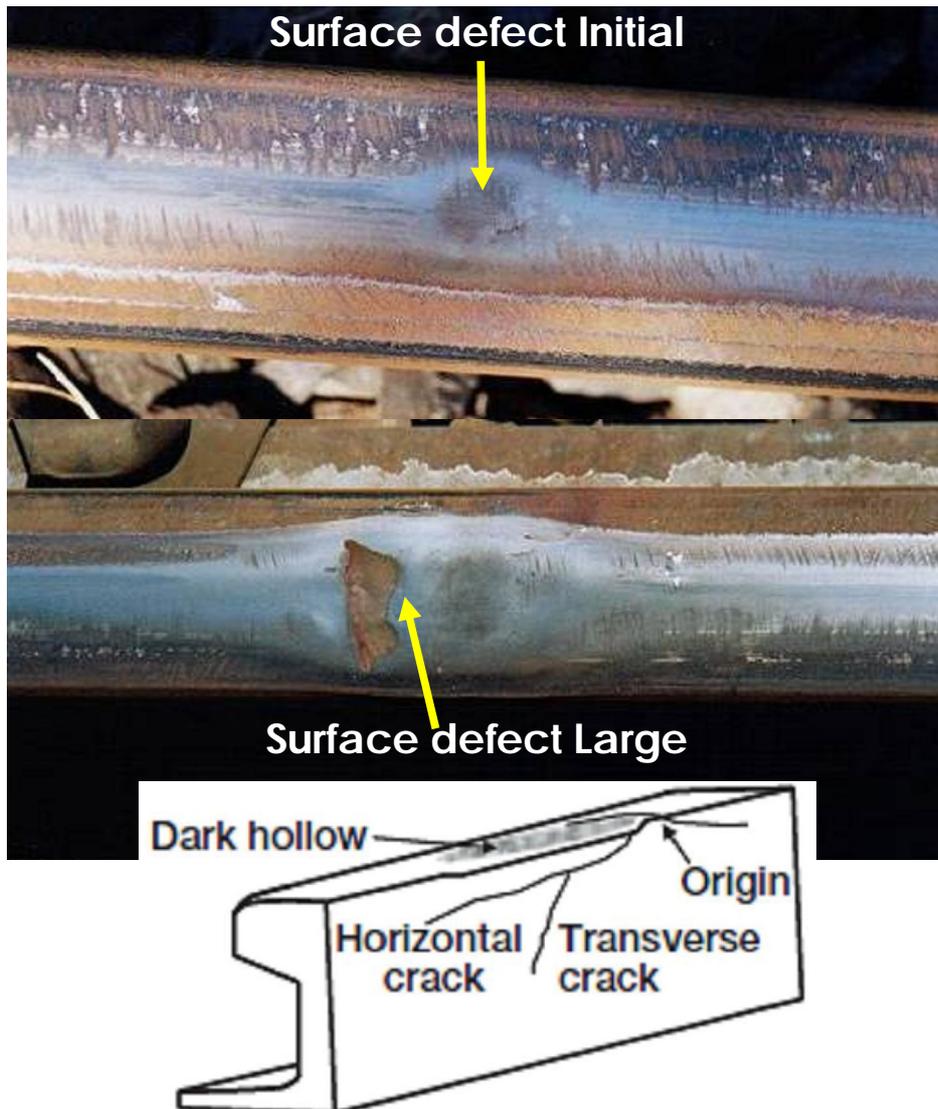
Unlike shelling, surface defects/squats appear in the crown area of straight rail sections. They are surface initiated defects formed by rolling contact fatigue and they are initiated from the gauge corner checking cracks. However, more recent work has shown that the more common squats that form on the crown of the rail head, are actually initiated from a hard and brittle layer with fine cracks present in the hard surface layer. A surface defect/squat is formed by two cracks, a leading crack and a trailing crack. Both these cracks propagate in opposite directions. The leading crack proceeds in the traffic direction, The leading crack is usually several times longer than the trailing crack and contains one main crack with a number of secondary or minor cracks branching off that crack. If preventive measures are not taken quickly, the crack will branch out and probably grow downward towards the rail web. In their initial stage, they look like depressions in the crown area. These defects can be prevented by grinding. Research has shown that rail grinding has an important role in reducing rail degradation, which can reduce rail brakes.

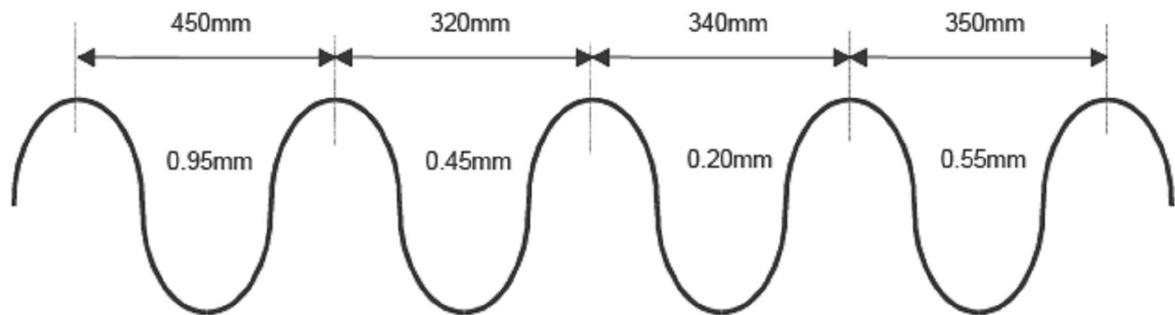
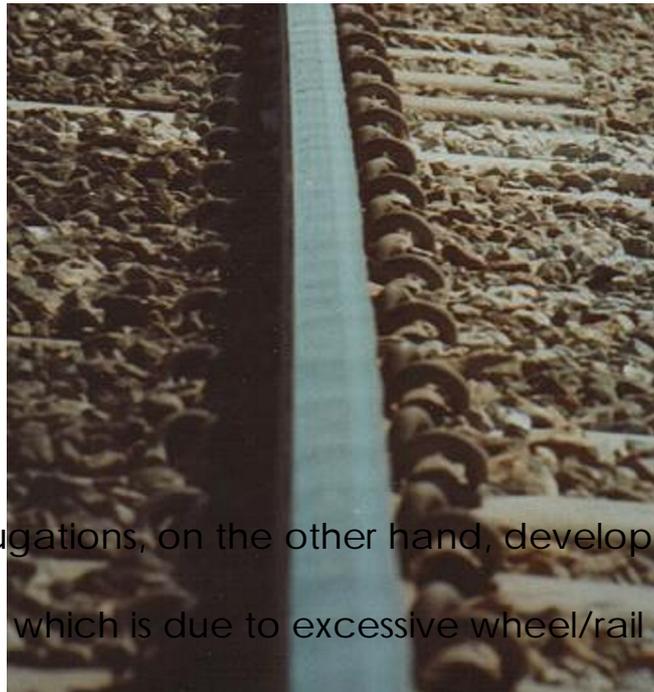
itself as peaks and valleys, a periodic irregularity of the rail surface. Long pitch corrugations are about 300mm in wavelength and they generally develop under higher axle load (> 20 tonnes) mixed freight and passenger train operations. The depth of these corrugations can range from 0.1mm to above 2.0mm, and can vary.

Vertical profile of long pitch corrugations

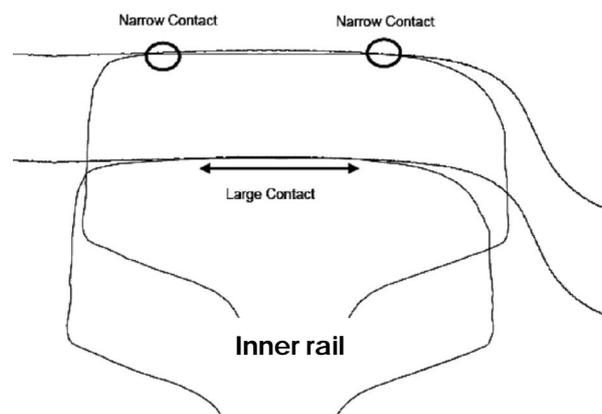
Some Wheel/rail contact conditions
